**BERYLLIUM BEHAVIOR IN THE NASA  
PLUM BROOK REACTOR**

by R. A. Hasse  
Lewis Research Center  
Cleveland, Ohio

**TECHNICAL PAPER** proposed for presentation at Fifth  
Conference of the Reactor Operations Division of  
the American Nuclear Society  
Denver, Colorado, August 9-11, 1971

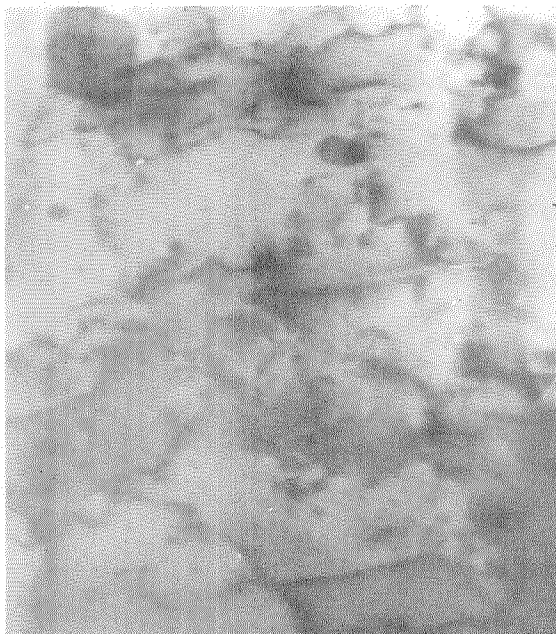
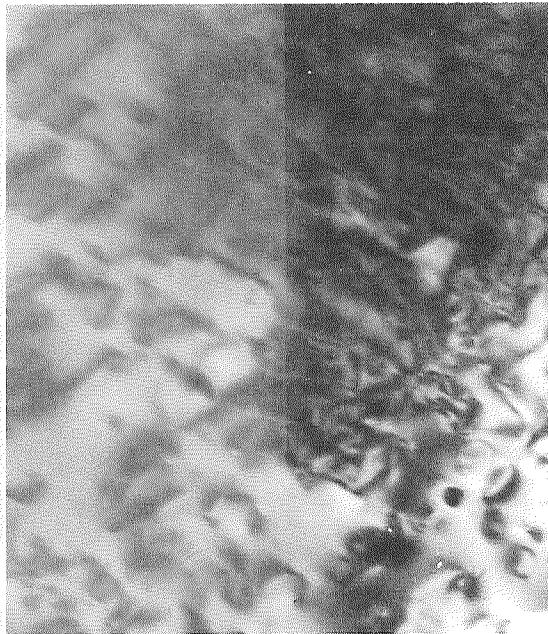
(A) 4Da LOW FLUX REGION.

(B) 16Ca INTERMEDIATE FLUX REGION.

(C) 20Ba HIGH FLUX REGION.

Figure 5. - Transmission electron micrographs of samples taken from various regions of moderator plate 1.

The transmission electron micrographs (Figs. 5 and 6) show an increasingly defected structure with increasing fluence. The dislocation loop densities given in Table IV are very approximate since the density varies considerably within a small area. The complexity of the dislocation structure is shown in Fig. 7. Figure 7(a) shows examples of helices, bowed and jogged dislocations and dislocations pinned by loops. Figure 7(b) shows in more detail the interactions between dislocations and loops and pinning of larger loops by small ones.

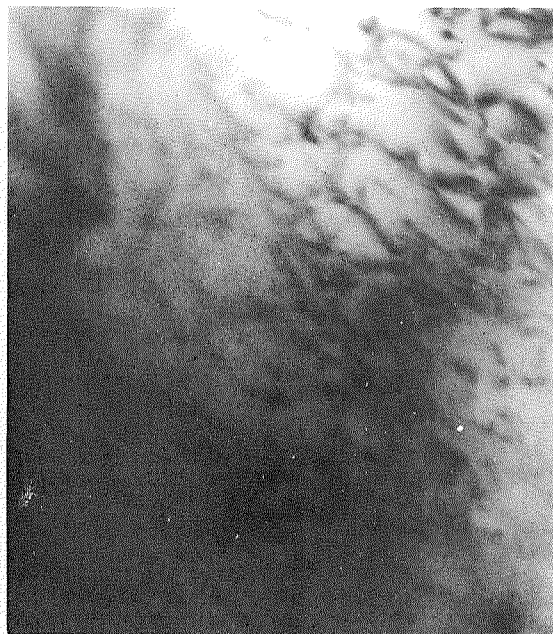
(A) 10a REGION OF LOW FLUX.

(B) 47a REGION OF INTERMEDIATE FLUX.

(C) 45d REGION OF HIGH FLUX.

Figure 6. - Transmission electron micrographs of samples taken from various regions of moderator plate 2.

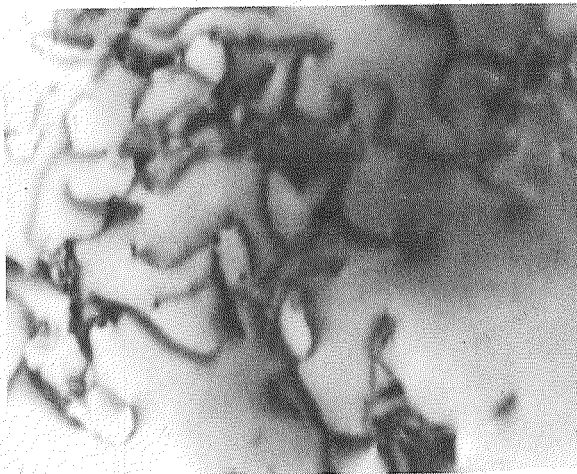
(A) GENERAL DISLOCATION STRUCTURE.

(B) DISLOCATION INTERACTIONS.

Figure 7. - Dislocation structure of sample 20B from plate S1.
